June 8, 2018

RE: UPA Number 1339667

PEOSH Notice of Health Hazards, Tiernan Hall

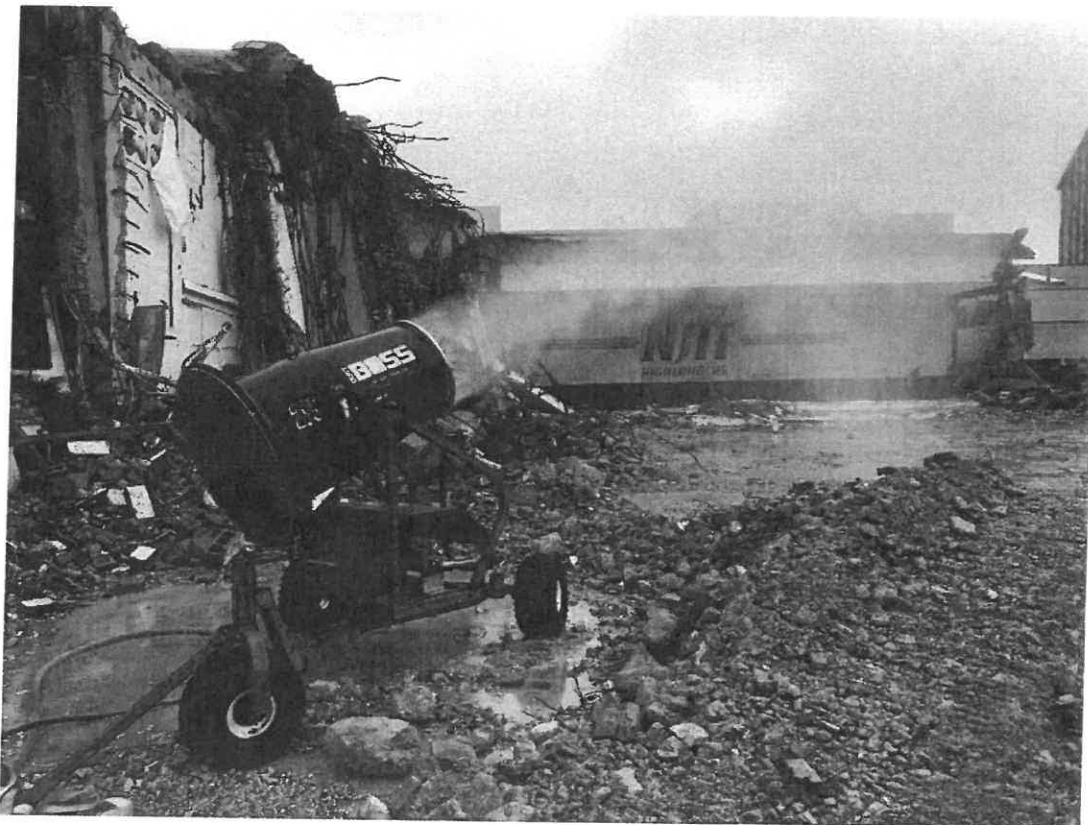
- In order to control dust generation at the site, the active demolition area is constantly being wet down with a 2-inch fire hose and sometimes a large misting device (Dust Boss – dust suppression articulating wet fan) as needed. Figure 1 (page 14) depicts the large misting device in use to control dust at the demolition site. Additionally, materials to be demolished are pre-soaked. Also, weather conditions may alter work schedule. For instance in times of high wind, only steel may be off-loaded to prevent generation of dust if other types of materials were handled.

Figure 1. Dust control device in use at demolition site
